Inspection Report

April 15, 2021

244 Spartan Ct.
Winchester Va

Hallmark Residential Services, Inc.

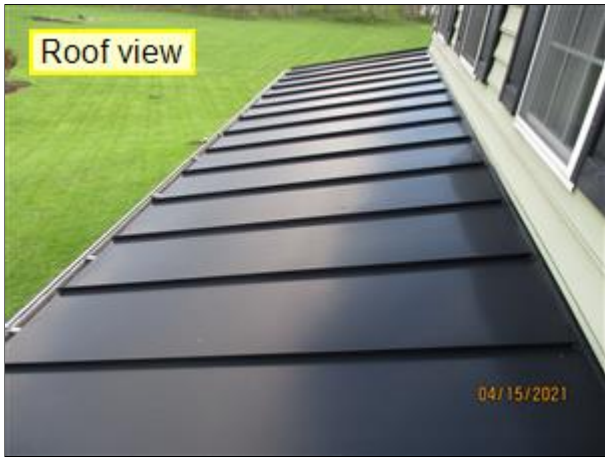
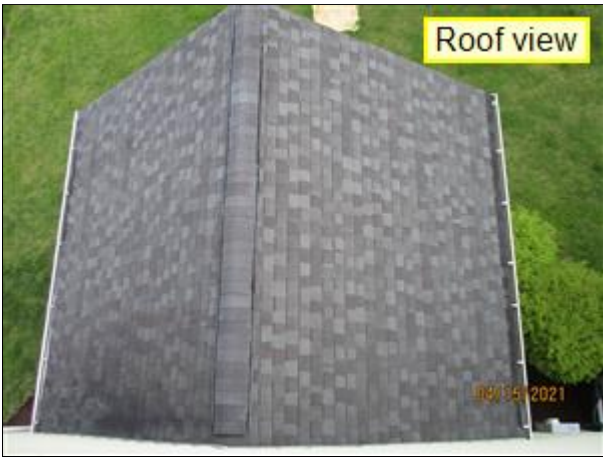
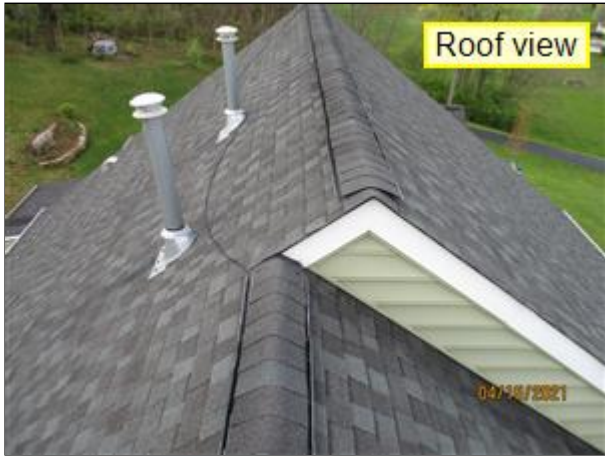
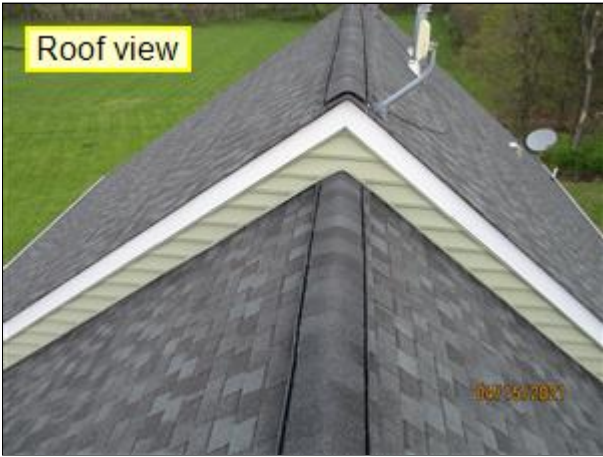
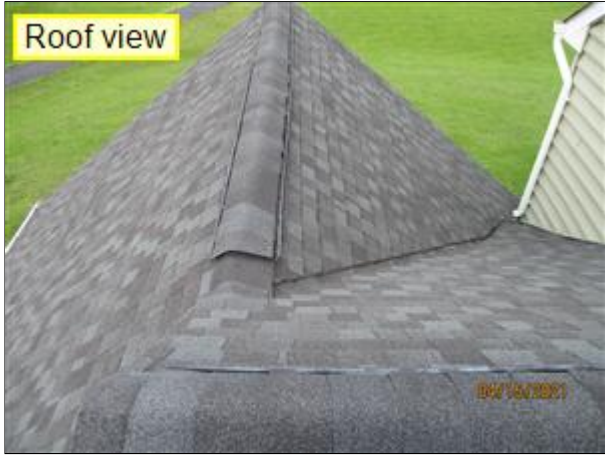
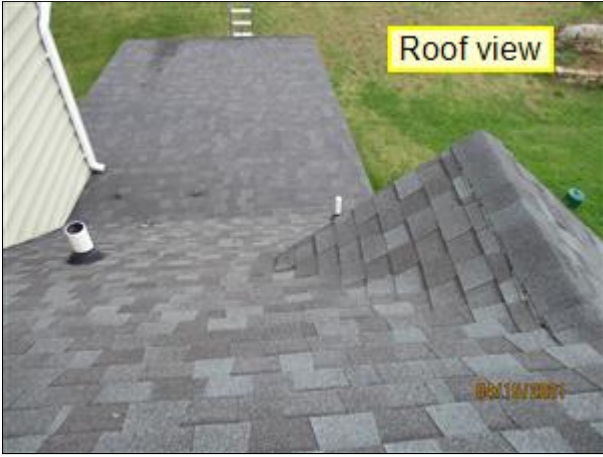
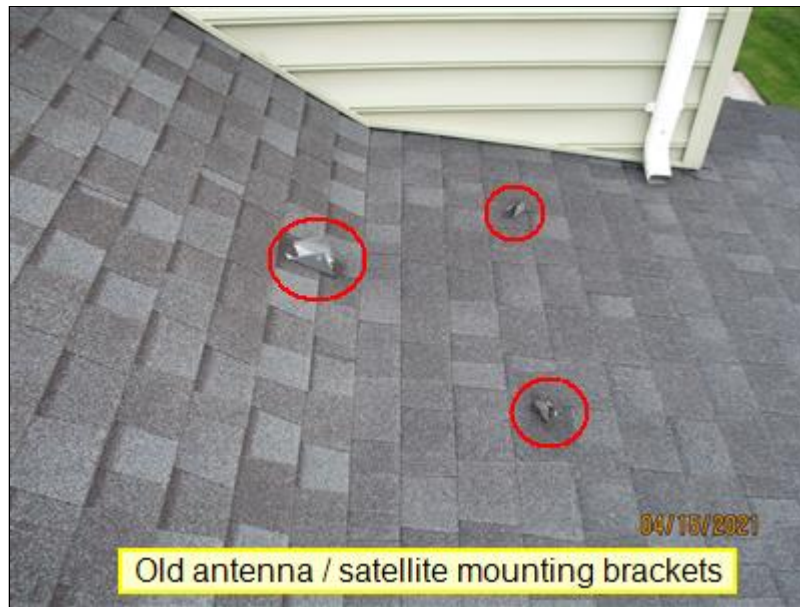
1.0 The roofing materials appear to remain serviceable, recommend monitoring as normal weathering and aging occur. Noted were remnants of a suspected antenna / satellite mounting bases secured to the shingle surface above the laundry area. Recommend monitoring the sealant around the metal brackets for deterioration to prevent potential moisture intrusion.

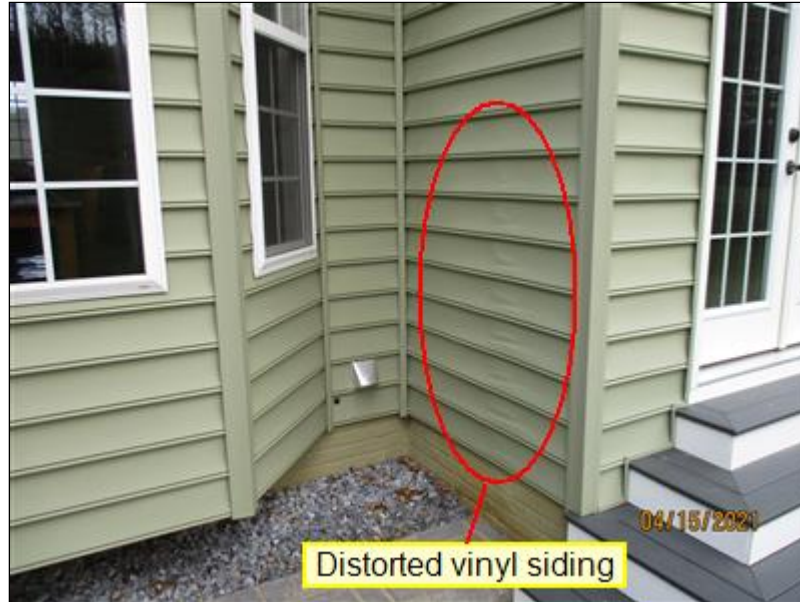
2.0 Picture 1

2.0 Area of distorted vinyl siding along the rear wall, appears to be caused by reflected sunlight off adjacent bay window glass (parabolic reflection).

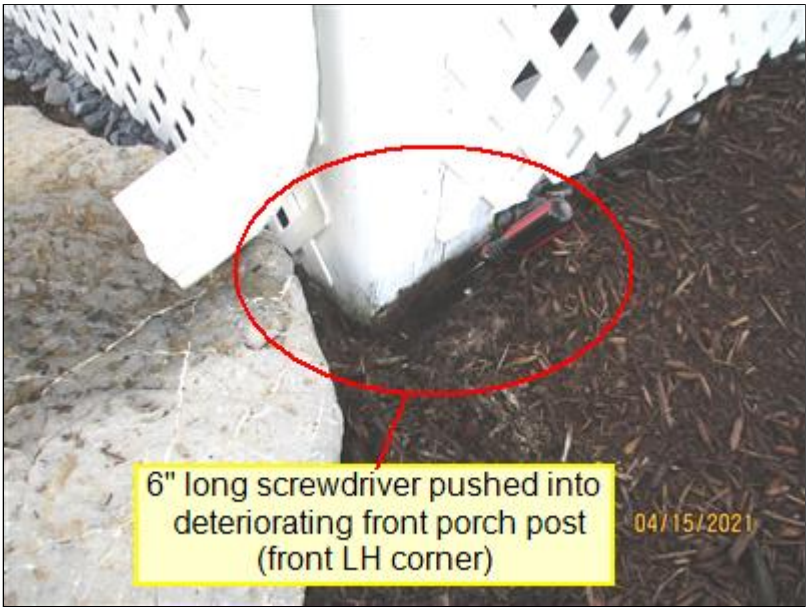
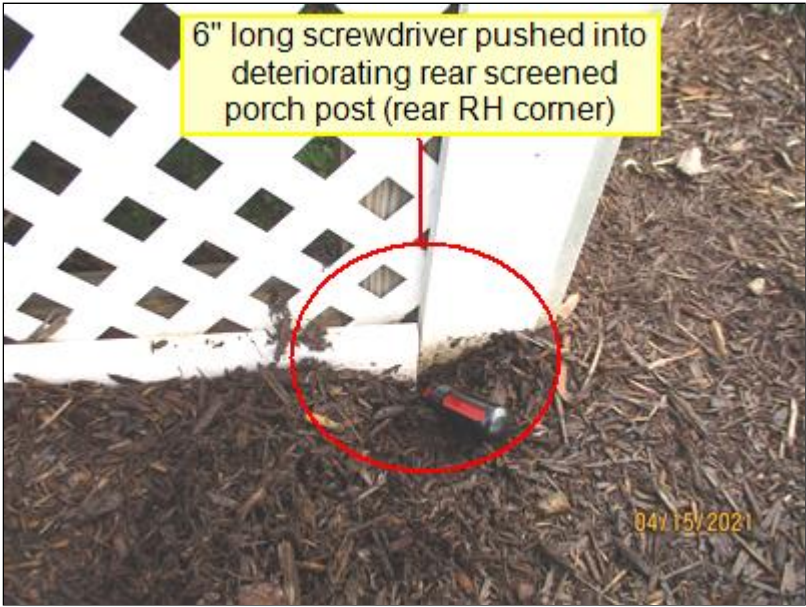
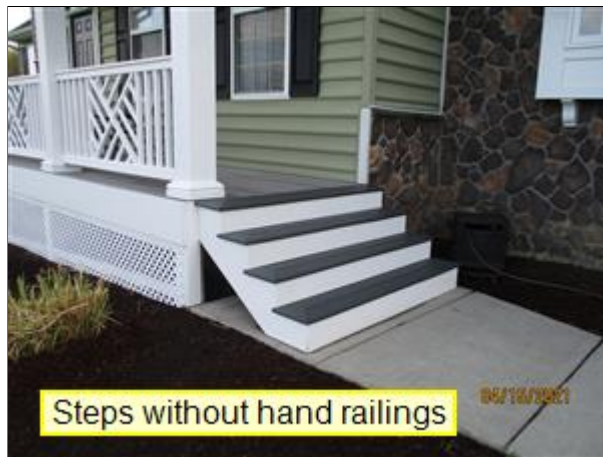
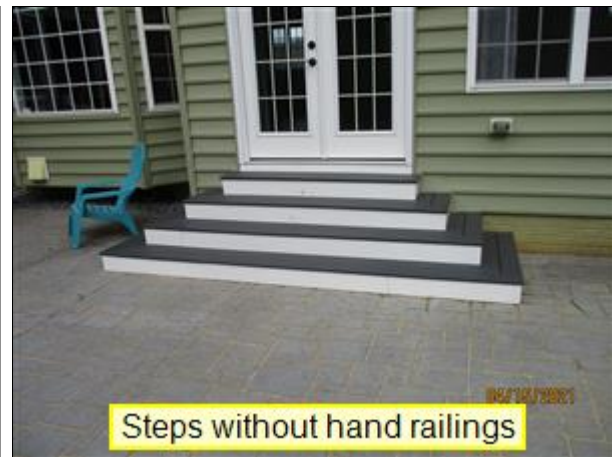
2.4 Moisture deterioration noted at one front porch and one rear screened porch 6x6 pressure treated support posts. Pressure treated wood in direct contact with the ground increases the potential of wood decay, I'm unable to determine the extent of the potential unseen damage below grade. Recommend further evaluation and correction as needed by a qualified contractor.

Noted were the lack of graspable hand railings along the front porch and rear patio stairs. Building and construction standards require hand railings for exterior stair with three or more steps (rises). Possibly acceptable at time of the home's original construction, but updating to current standards is recommended to improve safety and limit liabilities.

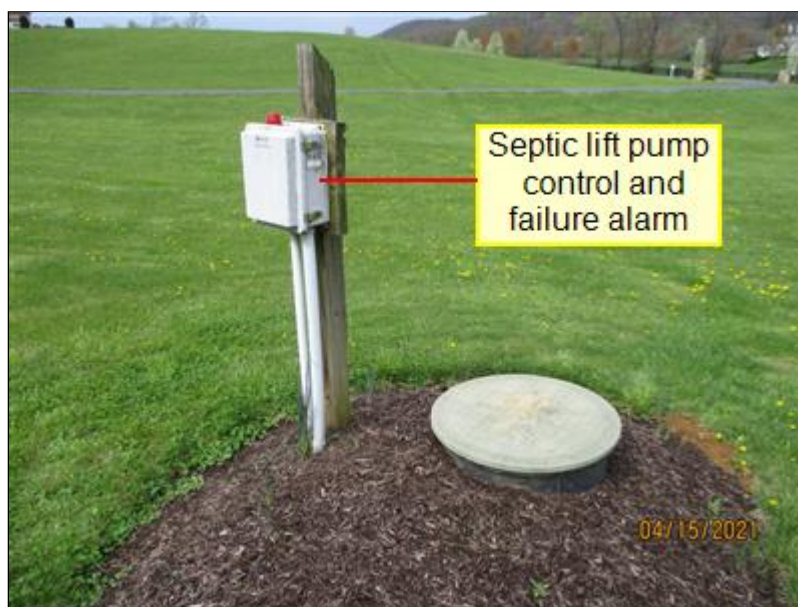
4.2 Picture 1

4.2 This inspection did not access the septic tank, septic lift pump, distribution box and drain field or determine it's locations. For a more detailed inspection, I recommend contacting a septic inspection company for further evaluation.

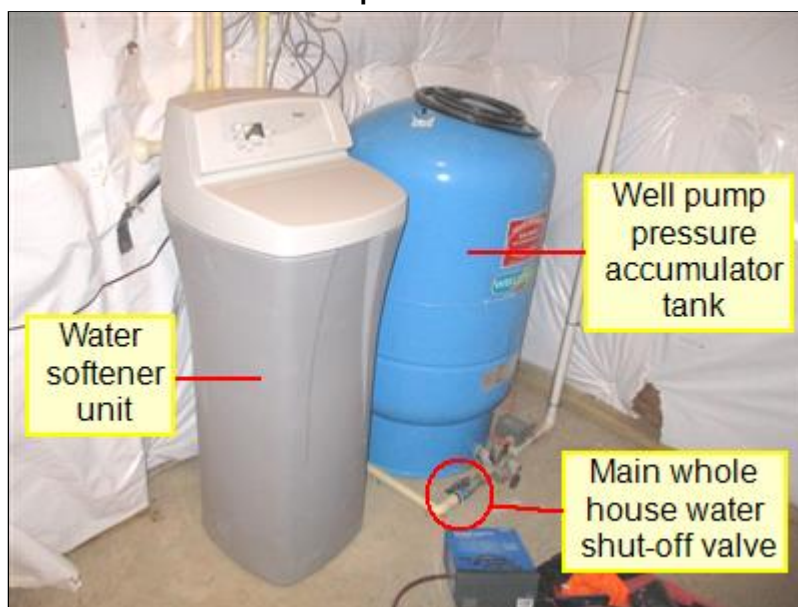
4.3 Picture 1

4.3 Main water shut-off valve is located near the well pressure accumulator tank in the basement.

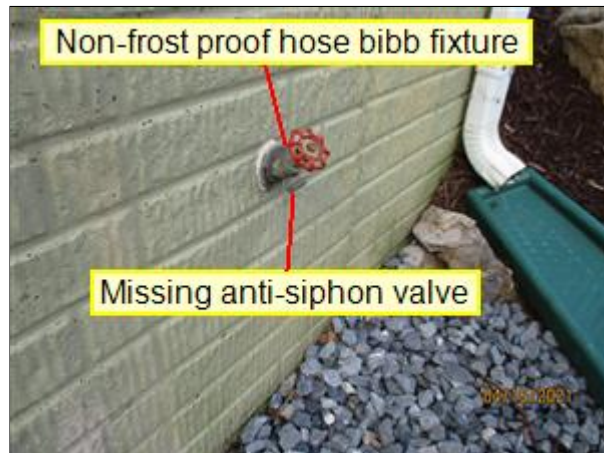
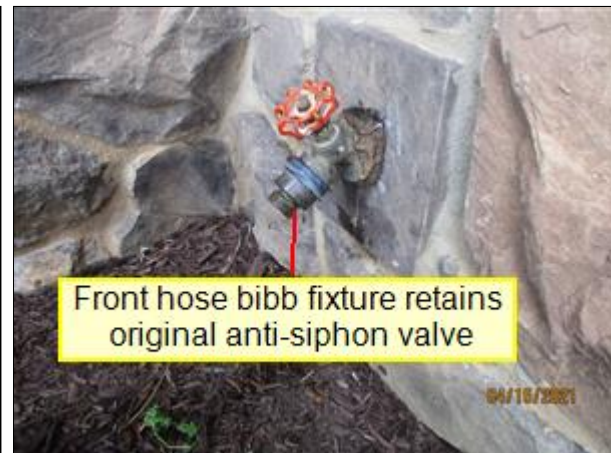
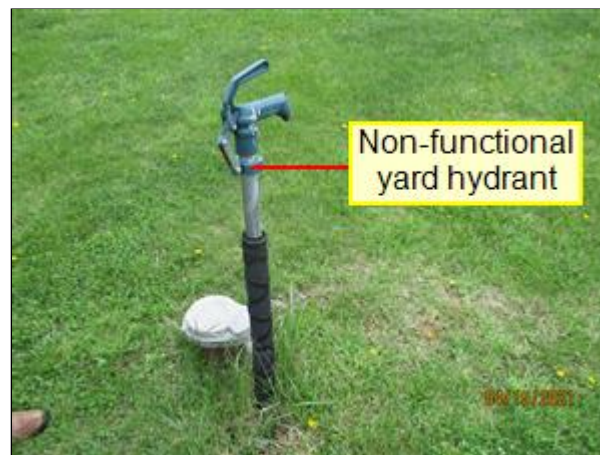
The LH end wall exterior hose bib faucet does not have an anti-siphon valve installed. An anti-siphon device (or vacuum breaker) prevents unsanitary water from being pulled back through a garden hose and contaminating your water system. Otherwise known as a "Cross Connection".

FYI: The exterior hose bibb faucets are not frost proof and require draining during freezing temperatures.

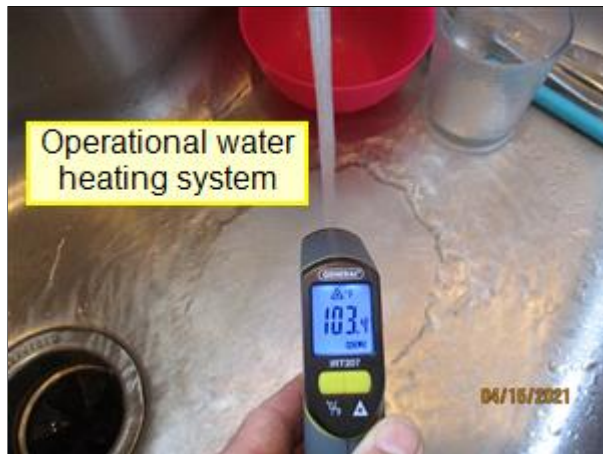
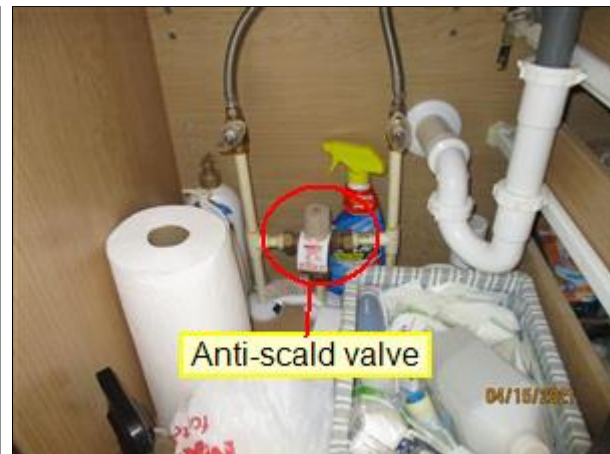
4.7 The water heating system was operational at time of the inspection.

FYI: The home is equipped with an anti-scald valve for the master bathroom shower. The valve is located underneath the master vanity sink cabinet.

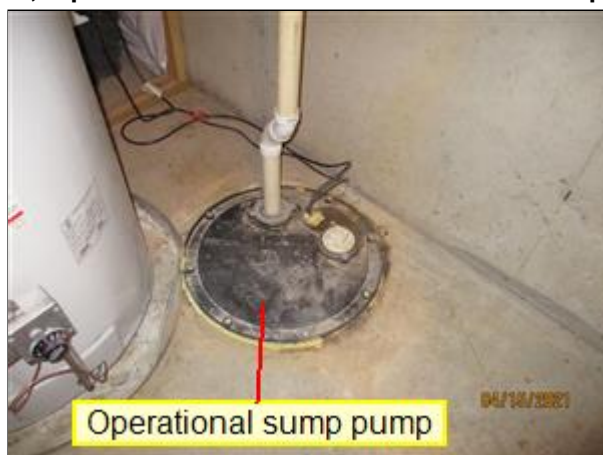
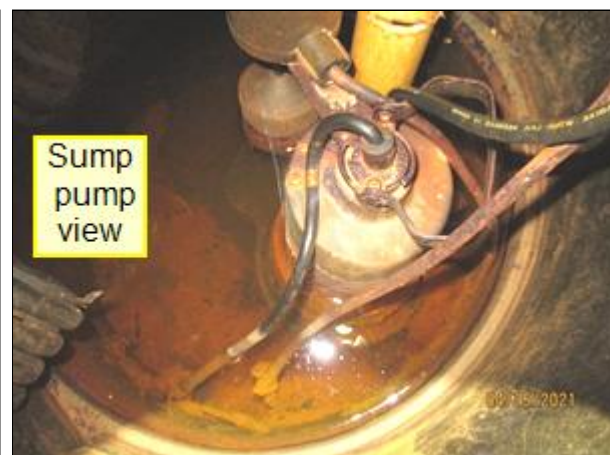
4.10 The existing sump pump was tested and operational at time of the inspection. The existing pump appears to be original, replacement is recommended for reliable operation.

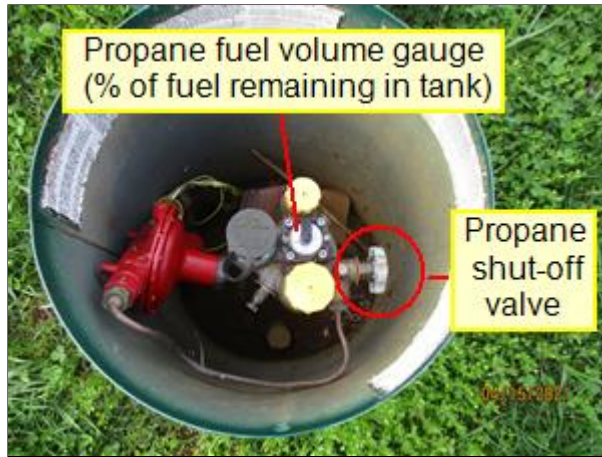
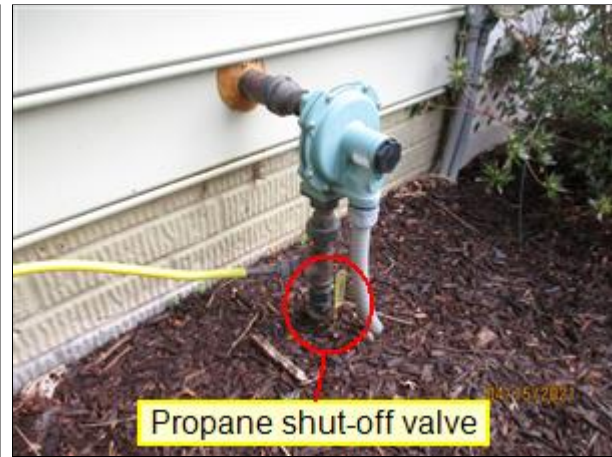
4.11 Propane fuel shut-off valves are located at the in-ground tank and wall mounted regulator.

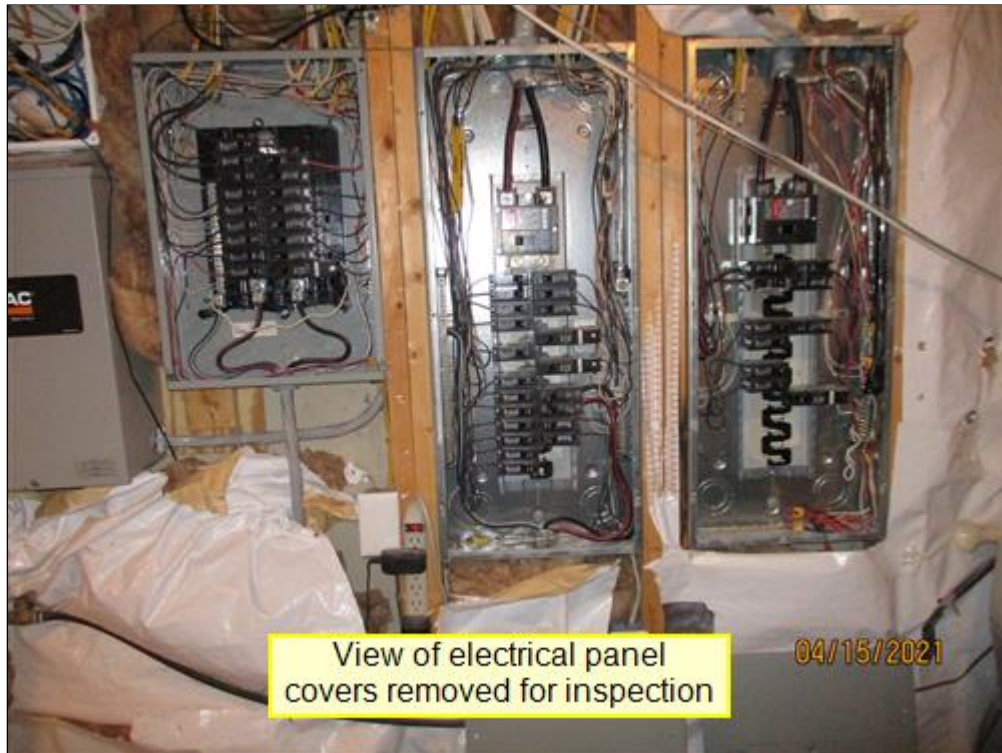
5.1 Picture 1

5.1 The main electrical distribution panels are located in the basement utility area.

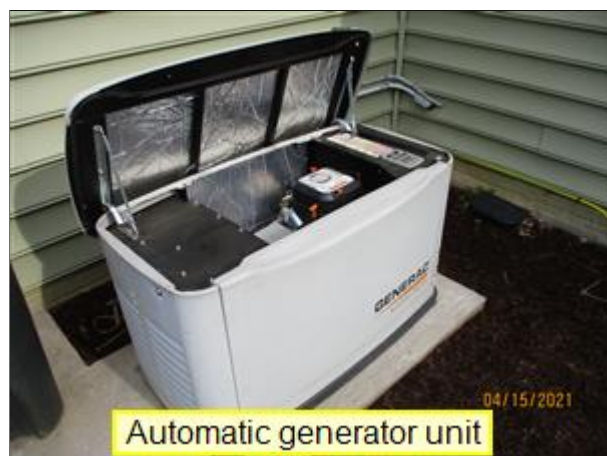
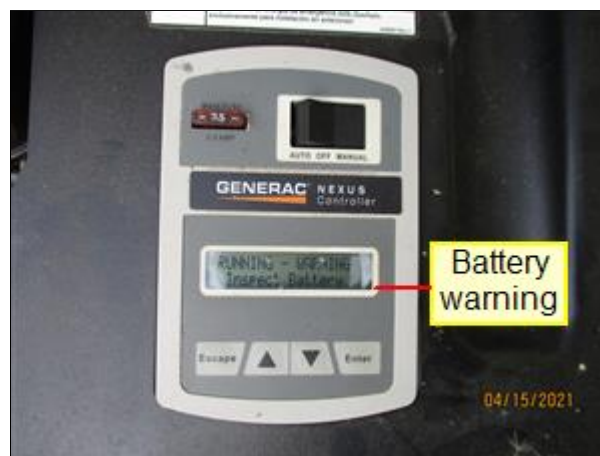
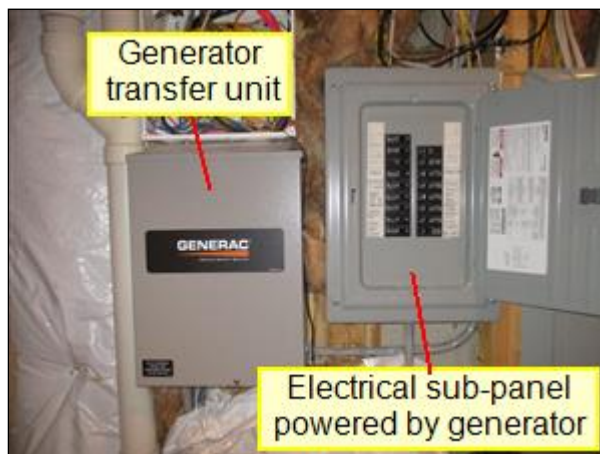
5.2 This home is equipped with an automatic generator system (20KW). The generator was test started at time of the inspection. The automatic transfer switch and circuitry were not tested for proper function. Recommend contacting manufacture for additional information and operators manual.

The digital display for the generator was indicating a potential battery warning, recommend further evaluation and correction as needed.

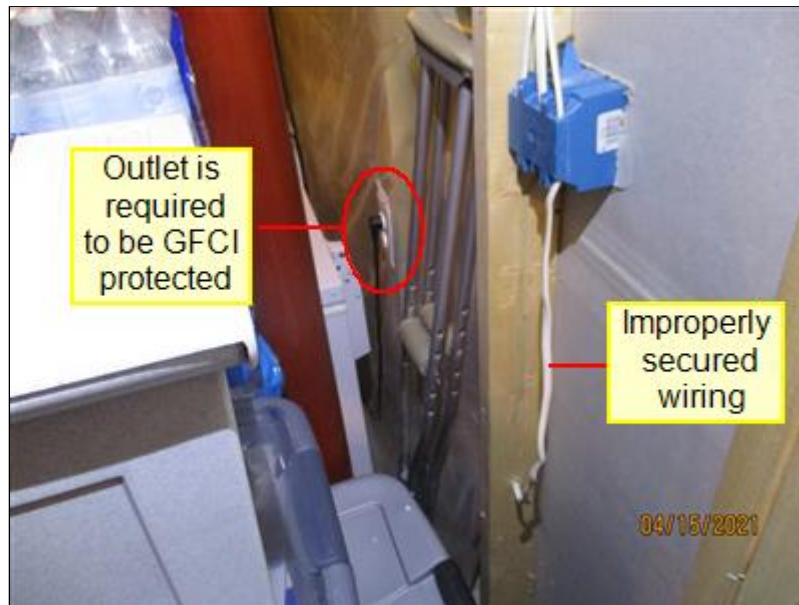
5.5 Picture 1

5.5 Improperly secured wiring extending to electrical receptacle in the basement storage area. Electrical installation requirements specify wiring to be secured to framing within 8" of junction boxes. Also, the electrical receptacle is required to be GFCI protected in an unfinished basement area. Most likely this wiring was installed after original construction.

Inspection of the complete electrical system was limited, I was unable to access or fully view many of the electrical junctions and wiring.

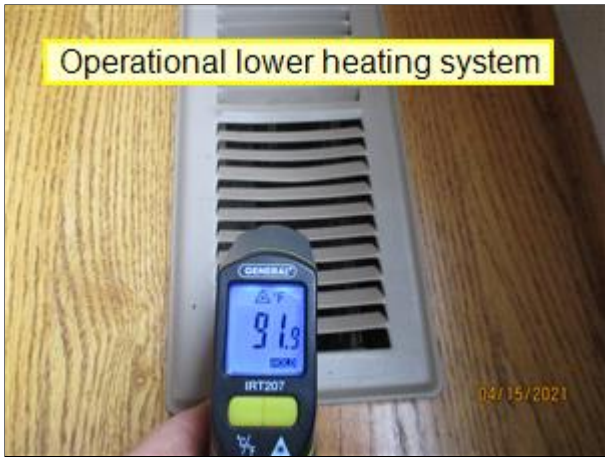
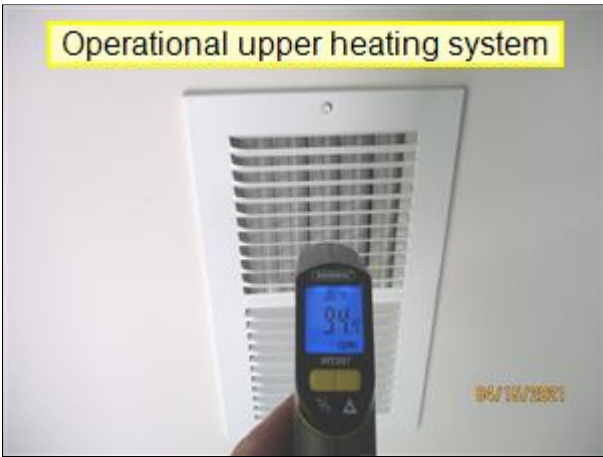
6.1 Both heating systems were operational at time of the inspection.

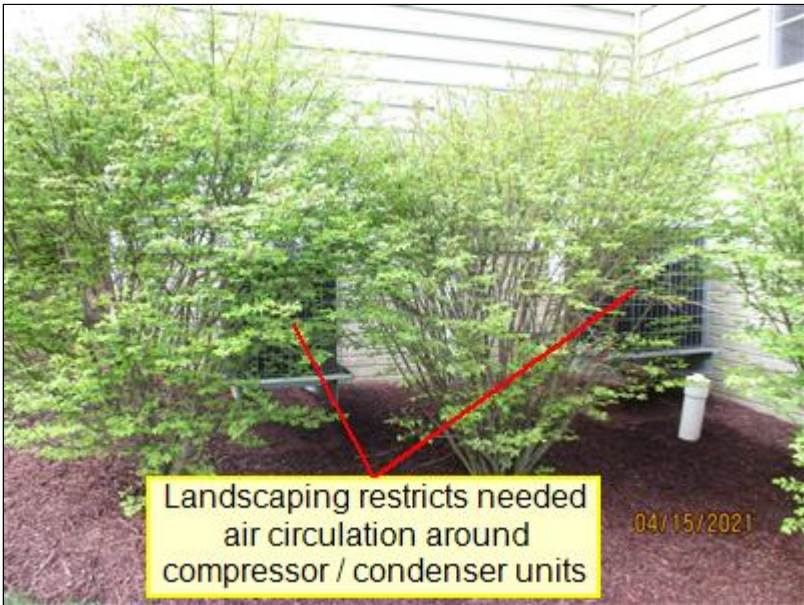
6.2 Picture 1

The overgrown landscaping around the exterior AC compressor / condenser units restricts the available air flow through the units. This reduces the operational efficiency of the HVAC systems.

6.2 Recommend review of the annual service log / records for both HVAC central AC systems. Recommend routine annual service and cleaning of the HVAC systems per the manufacture's service requirements if not completed within the previous year.

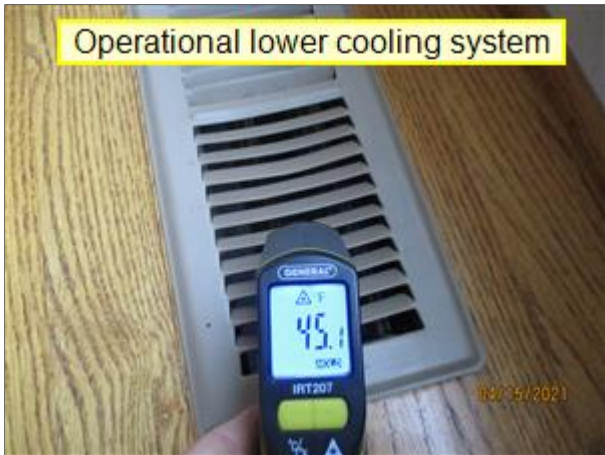
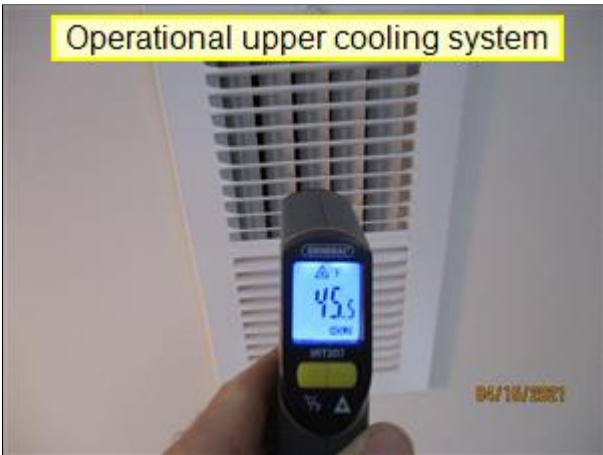
6.3 Both cooling systems were operational at time of the inspection.

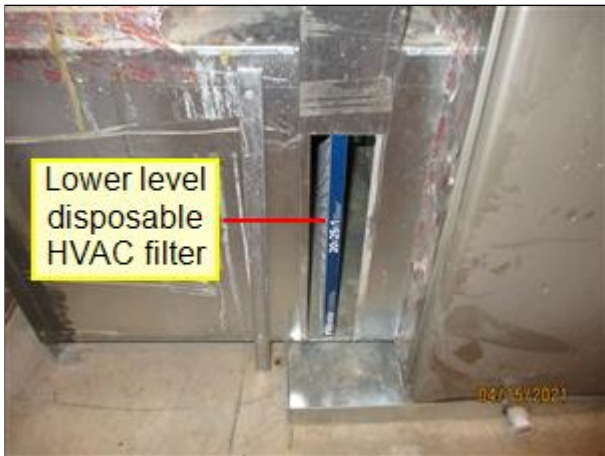
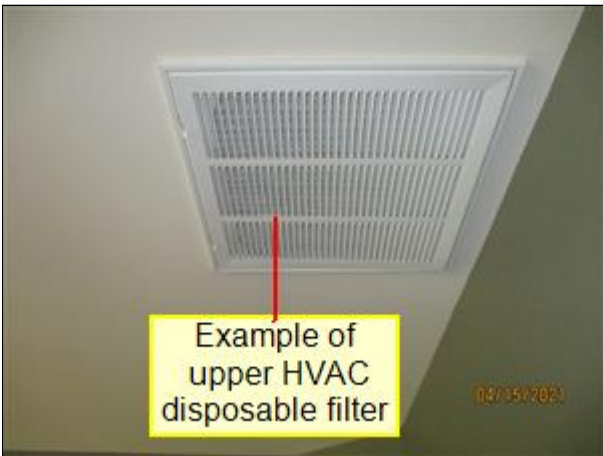
6.4 The lower HVAC system disposable filter is located in the base of the air handler unit. The upper HVAC system disposable filters are located in the return air registers. Filters should be changed every 4-6 weeks.

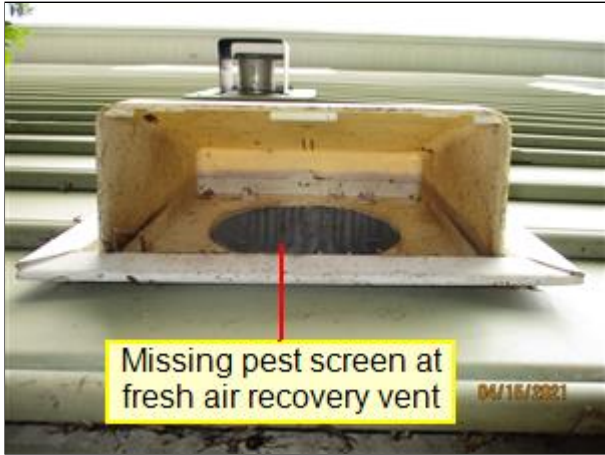
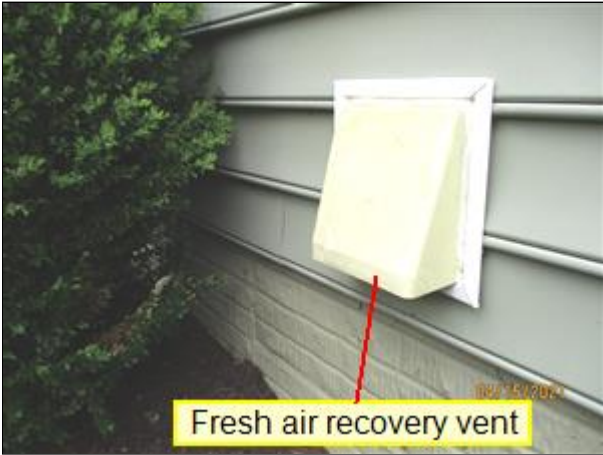
6.5 Recommend the installation of a pest screen at the fresh air recovery vent.

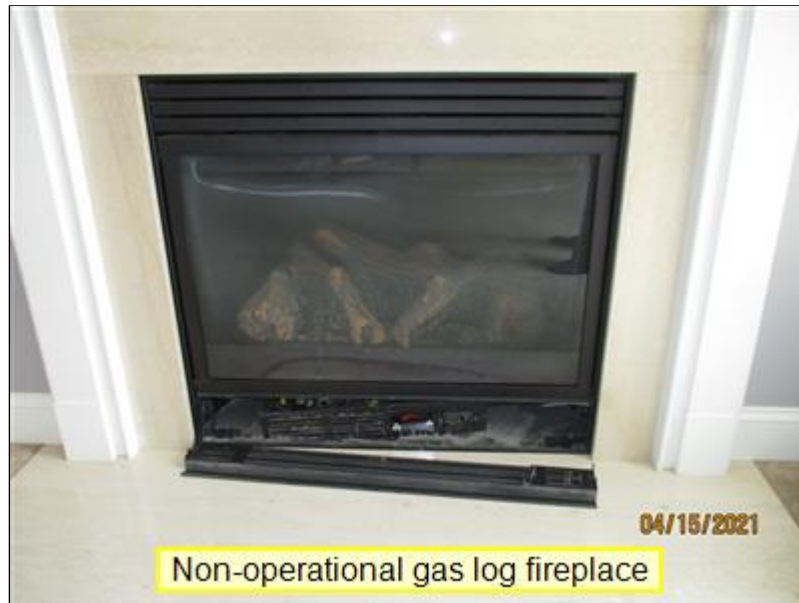
6.6 Picture 1

6.6 Gas fireplace was non-operation at time of the inspection, the spark ignition unit appears defective requiring replacement. Recommend reviewing the manufacture's operating requirements before use. Also recommend cleaning and adjustment by a qualified individual for proper fuel burning.

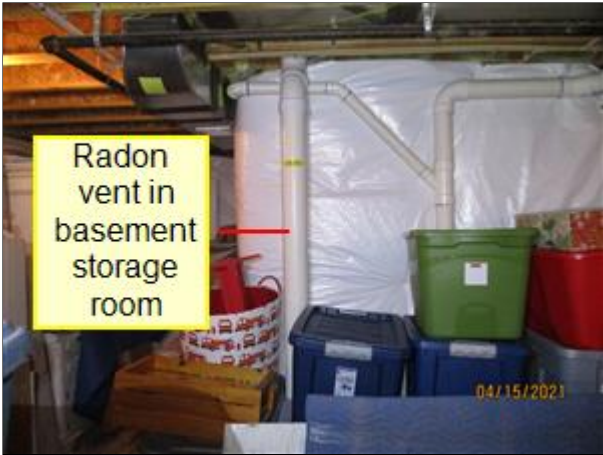
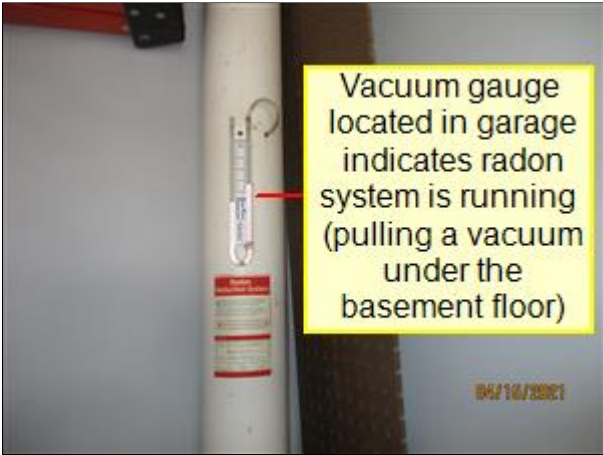
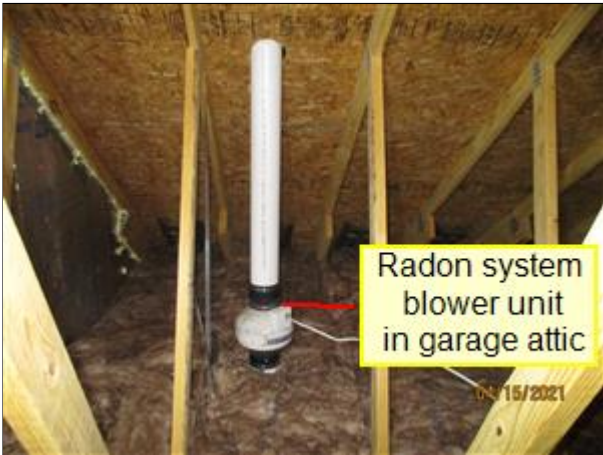
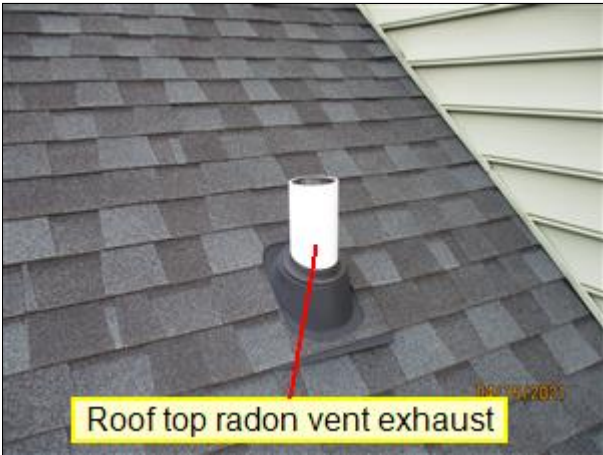
7.6 A Radon mitigation system is present in the subject home and appears to be operational.

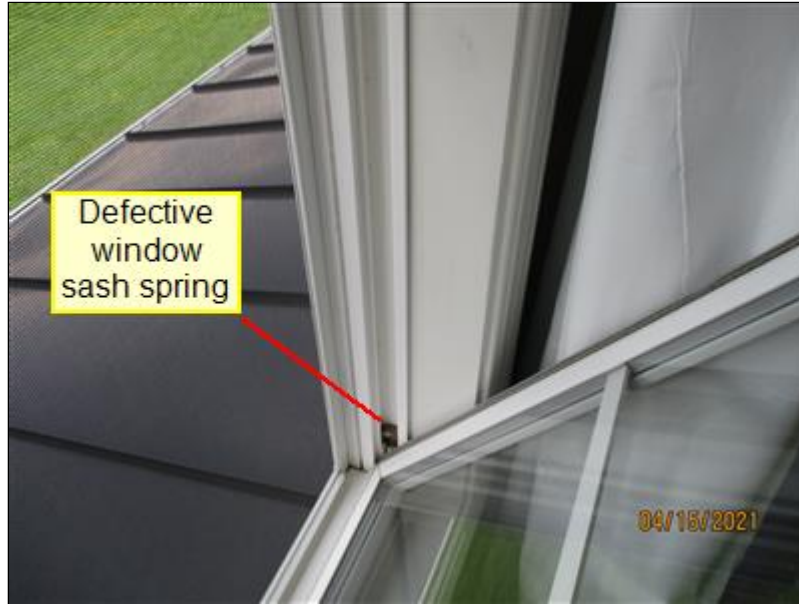
8.6 Picture 1

8.6 Defective sash counter balance spring mechanism at middle bedroom window. The window could drop unexpectedly possibly causing damage or injury. Recommend repairs by a window / glass repair contractor.

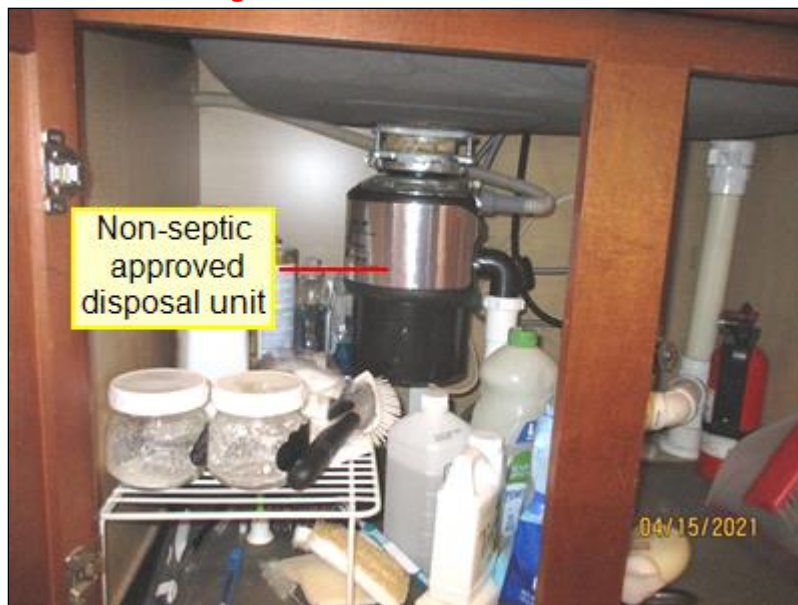
9.1 Picture 1

9.1 The existing kitchen sink disposal unit is not a septic system approved type. The use of garbage disposals will potentially add to the build up of sludge in the septic tank, unless the septic tank and drain field are designed to accommodate the increase water and organic load created from these devices.

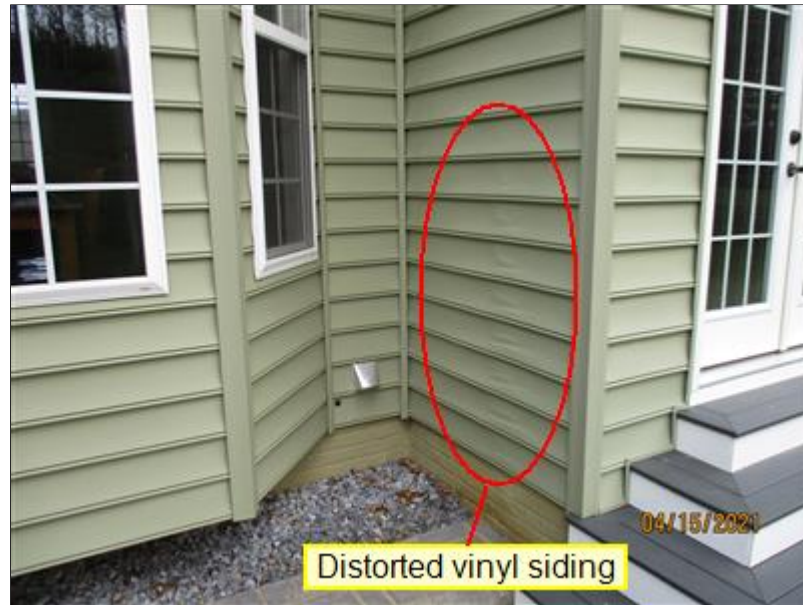
2.0 Picture 1

Area of distorted vinyl siding along the rear wall, appears to be caused by reflected sunlight off adjacent bay widow glass (parabolic reflection).

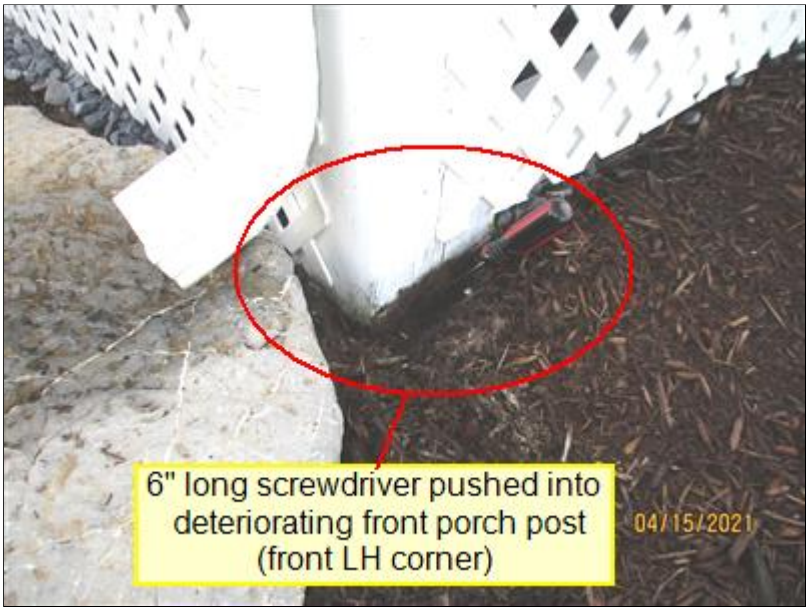
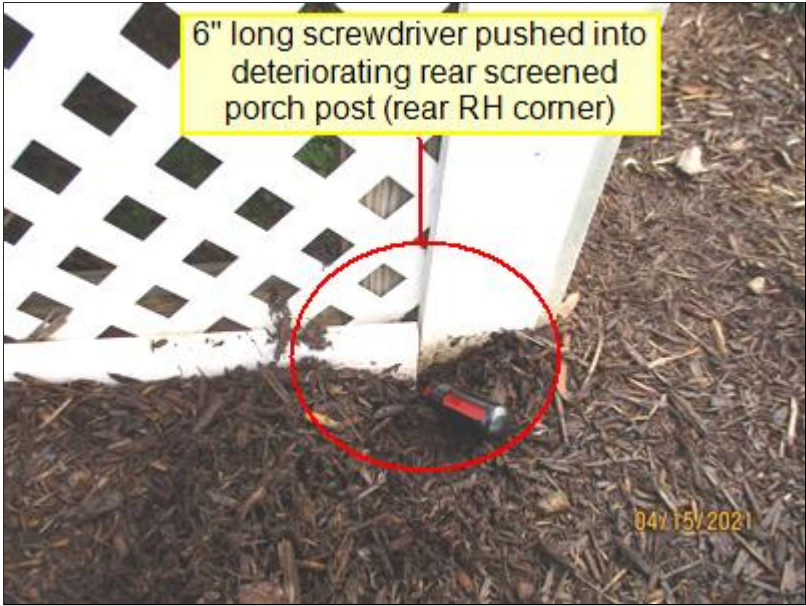
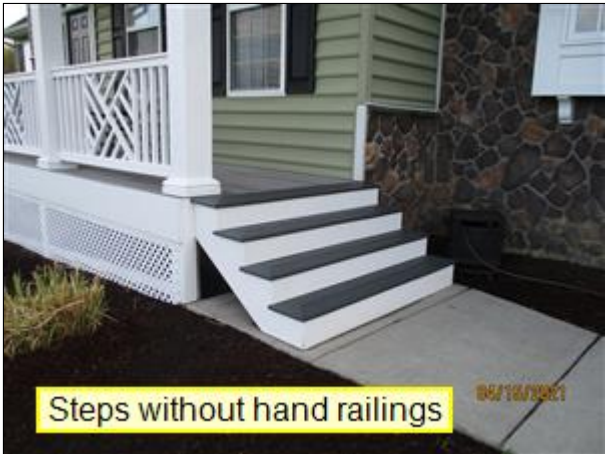
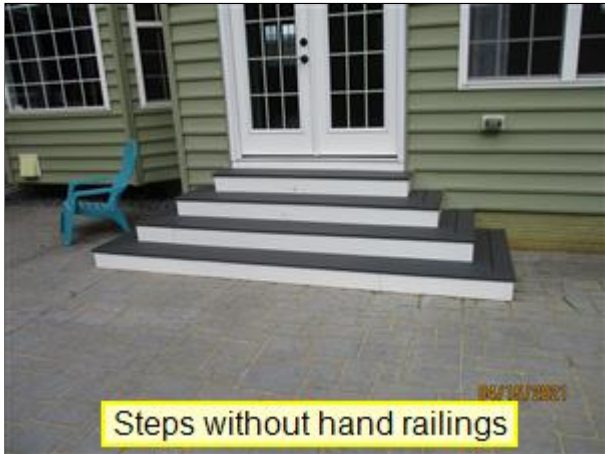
Moisture deterioration noted at one front porch and one rear screened porch 6x6 pressure treated support posts. Pressure treated wood in direct contact with the ground increases the potential of wood decay, I'm unable to determine the extent of the potential unseen damage below grade. Recommend further evaluation and correction as needed by a qualified contractor.

Noted were the lack of graspable hand railings along the front porch and rear patio stairs. Building and construction standards require hand railings for exterior stair with three or more steps (rises). Possibly acceptable at time of the home's original construction, but updating to current standards is recommended to improve safety and limit liabilities.

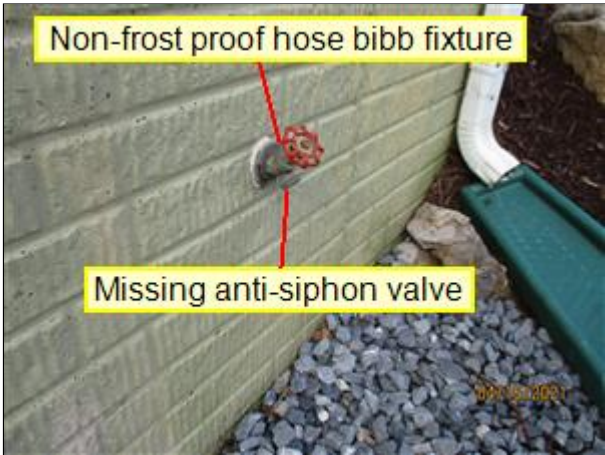
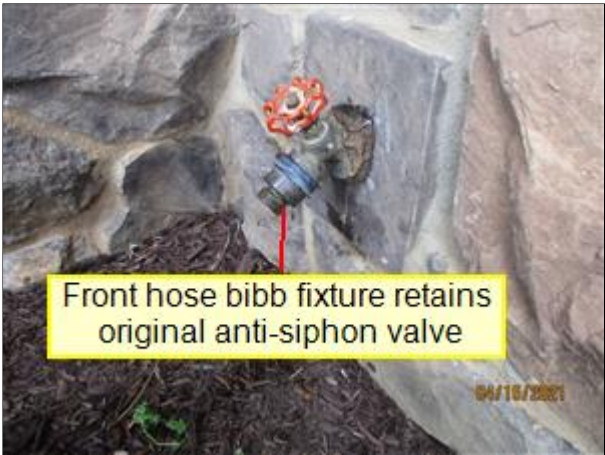
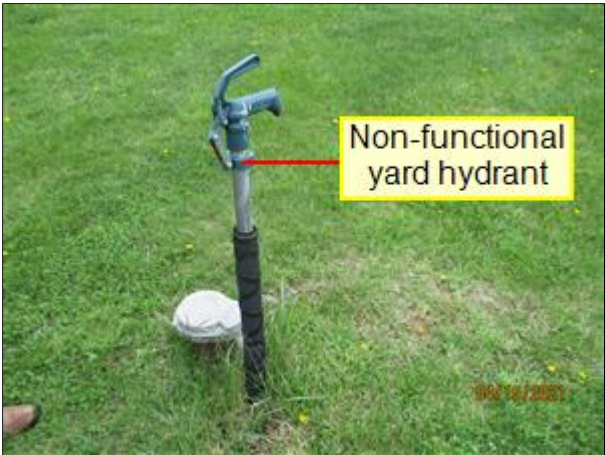
The LH end wall exterior hose bib faucet does not have an anti-siphon valve installed. An anti-siphon device (or vacuum breaker) prevents unsanitary water from being pulled back through a garden hose and contaminating your water system. Otherwise known as a "Cross Connection".

FYI: The exterior hose bibb faucets are not frost proof and require draining during freezing temperatures.

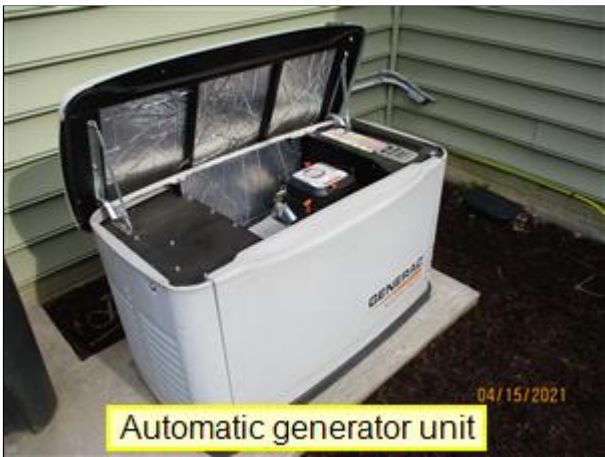
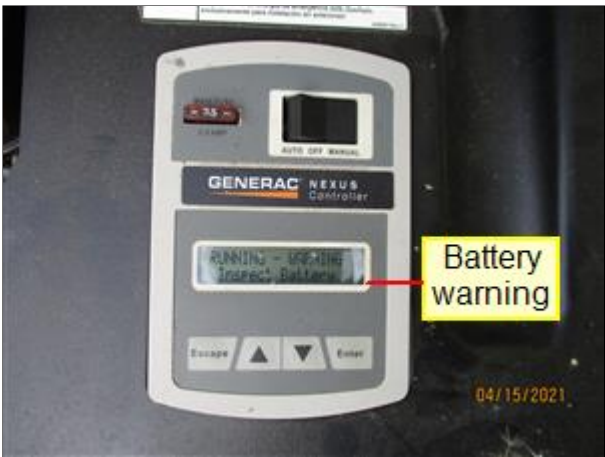
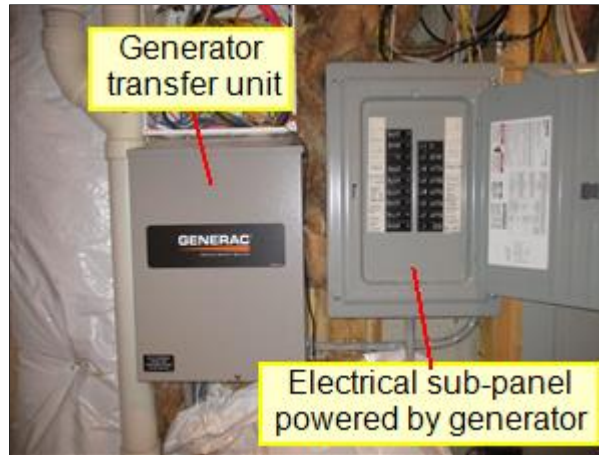
This home is equipped with an automatic generator system (20KW). The generator was test started at time of the inspection. The automatic transfer switch and circuitry were not tested for proper function. Recommend contacting manufacture for additional information and operators manual.

The digital display for the generator was indicating a potential battery warning, recommend further evaluation and correction as needed.

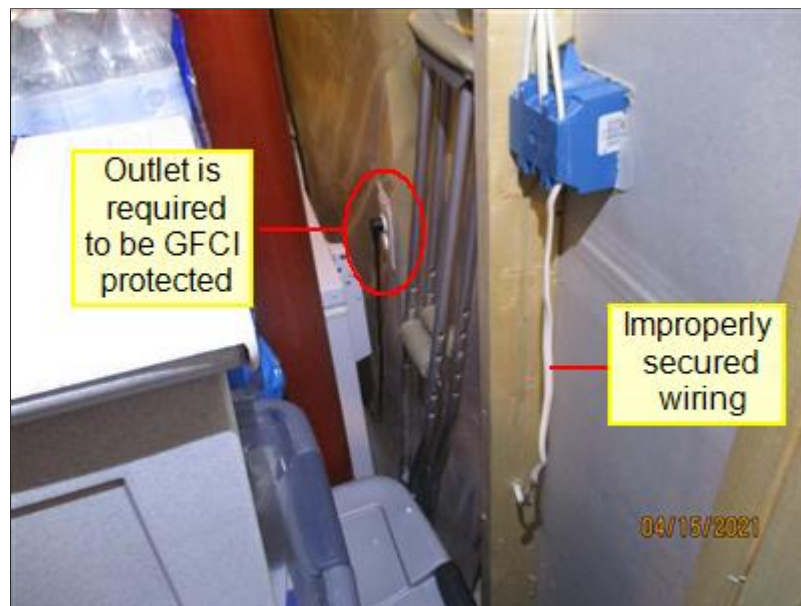
5.5 Picture 1

Improperly secured wiring extending to electrical receptacle in the basement storage area. Electrical installation requirements specify wiring to be secured to framing within 8" of junction boxes. Also, the electrical receptacle is required to be GFCI protected in an unfinished basement area. Most likely this wiring was installed after original construction.

Inspection of the complete electrical system was limited, I was unable to access or fully view many of the electrical junctions and wiring.

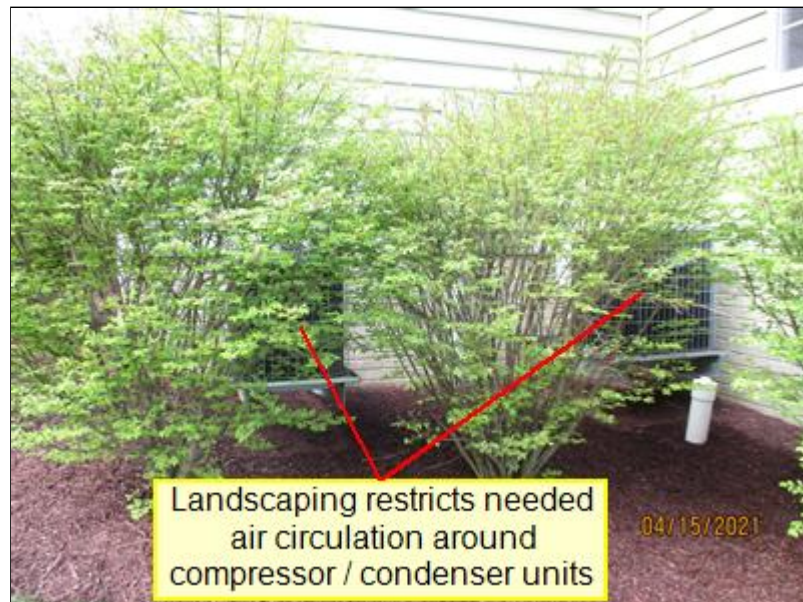
6.2 Picture 1

The overgrown landscaping around the exterior AC compressor / condenser units restricts the available air flow through the units. This reduces the operational efficiency of the HVAC systems.

Recommend review of the annual service log / records for both HVAC central AC systems. Recommend routine annual service and cleaning of the HVAC systems per the manufacture's service requirements if not completed within the previous year.

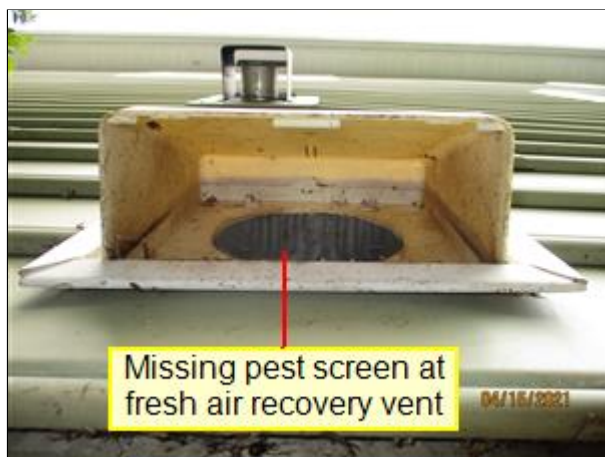
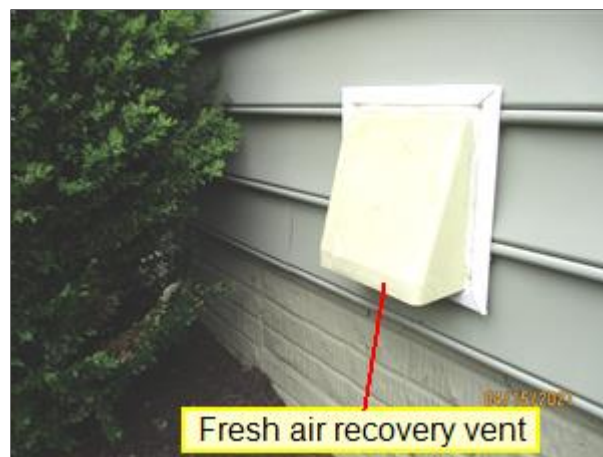
Recommend the installation of a pest screen at the fresh air recovery vent.

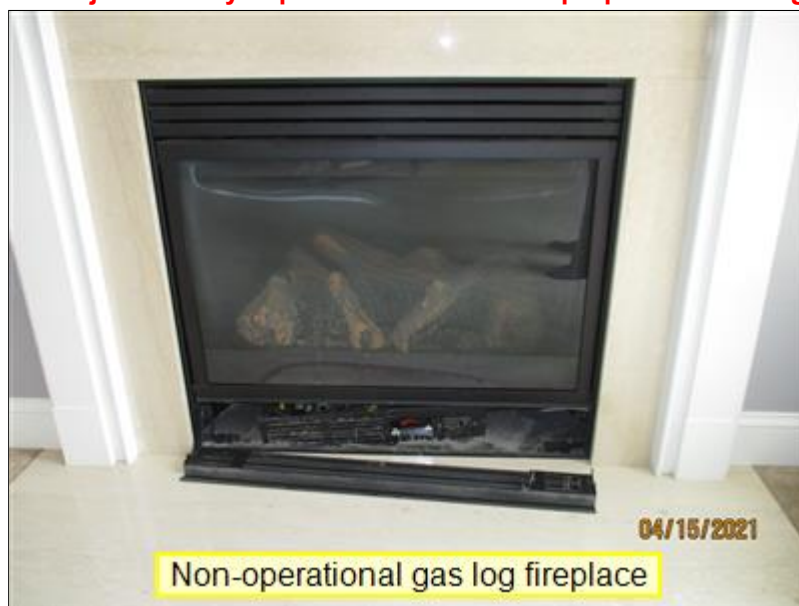
6.6 Picture 1

Gas fireplace was non-operation at time of the inspection, the spark ignition unit appears defective requiring replacement. Recommend reviewing the manufacture's operating requirements before use. Also recommend cleaning and adjustment by a qualified individual for proper fuel burning.
