Inspection Report

April 15, 2021

244 Spartan Ct.
Winchester Va

Hallmark Residential Services, Inc.

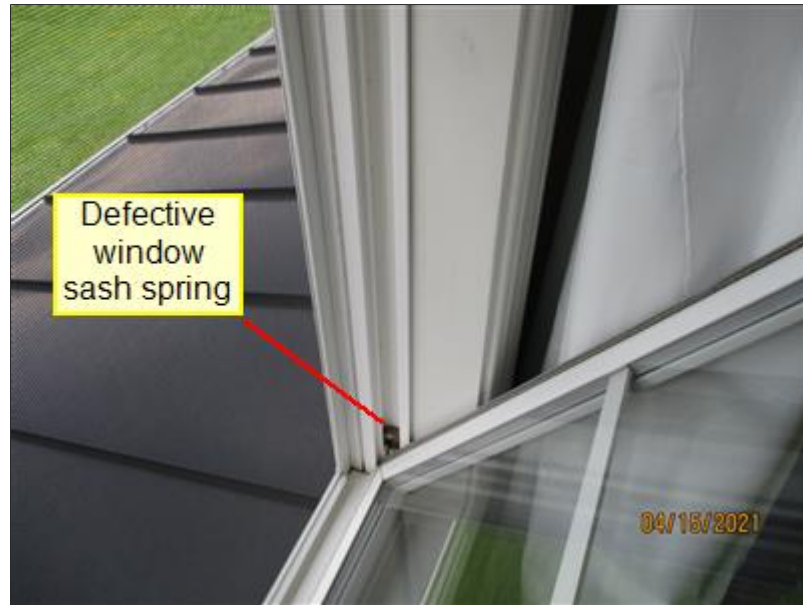
8.6 Picture 1

Defective sash counter balance spring mechanism at middle bedroom window. The window could drop unexpectedly possibly causing damage or injury. Recommend repairs by a window / glass repair contractor.

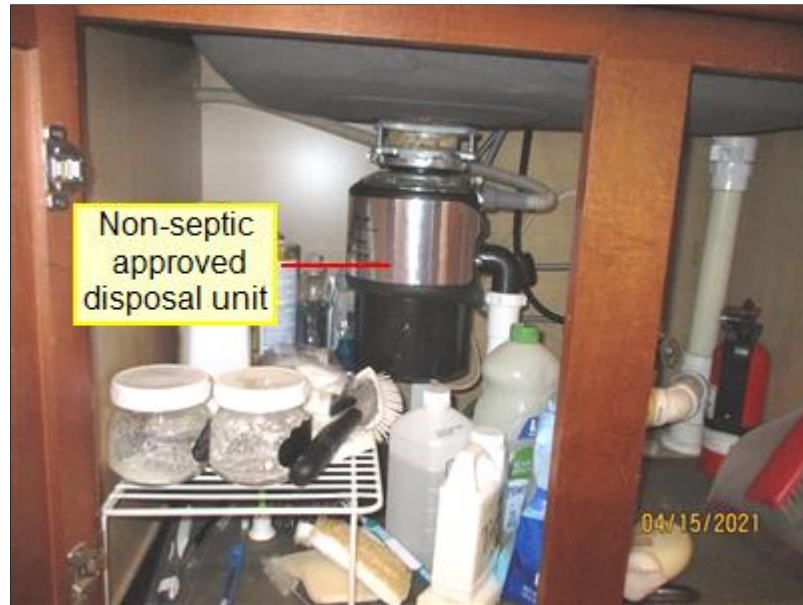
9.1 Picture 1

9.1 The existing kitchen sink disposal unit is not a septic system approved type. The use of garbage disposals will potentially add to the build up of sludge in the septic tank, unless the septic tank and drain field are designed to accommodate the increase water and organic load created from these devices.
